# Sample I/I Sources found by Thompson Flow Investigations

## *Some Typical & Some Unusual*

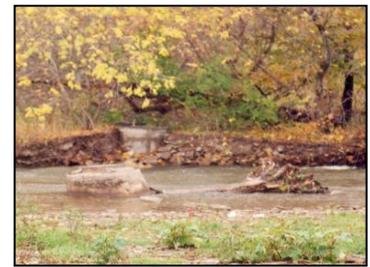
9. A sanitary sewer manhole in a river valley which had been completely exposed as the river moved within it's floodplain. When found by Mr. Thompson the manhole was well out into the active stream and had been partially knocked over by a large tree trunk (which was still there, looking like a medieval battering ram).The solution was to eliminate and seal up the manhole.

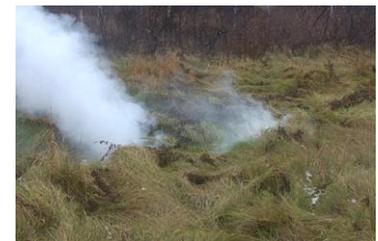
10. A broken, shallow sewer line in a floodplain. The ground above the sewer had fallen in to it exposing the sewer as it crossed a floodplain area. Whenever a nearby creek flooded this field, massive inflow to the sanitary sewer occurred.

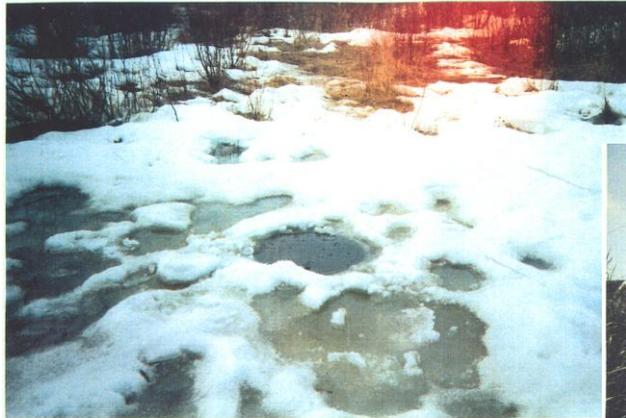
12. Trunk sewer manholes in a deep ditch alongside a highway. A row of such manholes were found which became overtopped during spring snowmelt and also had extreme inflow through their cracked adjusters. Another nearby manhole in a field was flooded in the spring even though it was about 30cm above ground. These manholes were all extended above flooding levels and sealed. Very significant reductions in spring period I/I were then observed at the downstream sewage plant.

MH 8-223 APRIL 4, 1991 SULLIVAN ROAD STREET ALLOWANCE  
MELT WATER HAS BUILT UP AND IS FLOWING INTO MH.  
(MELT WATER OVER 300mm DEEP)

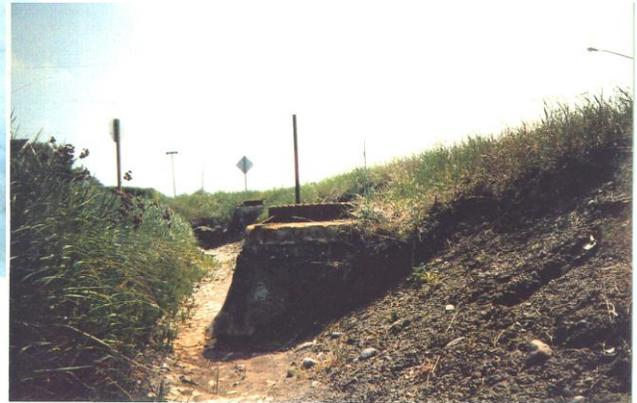
MH 8-260 & MH 8-259 HIGHWAY 144  
MANHOLES IN DITCHLINE CAN BE OVERTOPPED DURING HEAVY STORM FLOWS
